Technical Paper T-134

TEMPERATURE SEGREGATION/ Temperature Differential Damage

by J. Don Brock, PhD., P.E. Astec Industries, Inc.

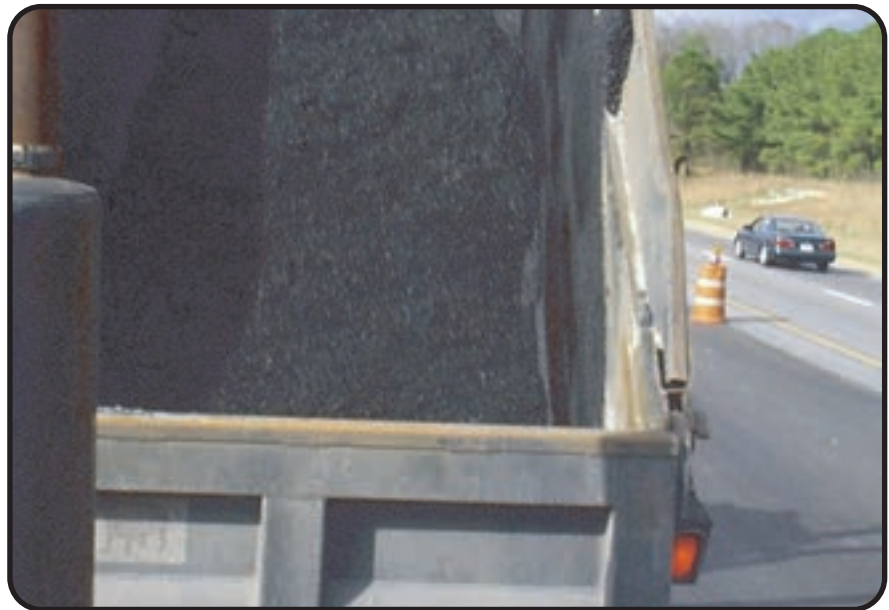
Through the use of an infrared camera, along with the ability of the camera to not only take videos but also to capture photographs of specific areas, and, through the use of a software program which can plot the profile, it became obvious that significant temperature differentials were occurring. Figure 1 and Figure 2 show the differential temperature as mix is being dumped from a truck bed, along with the spot temperatures.

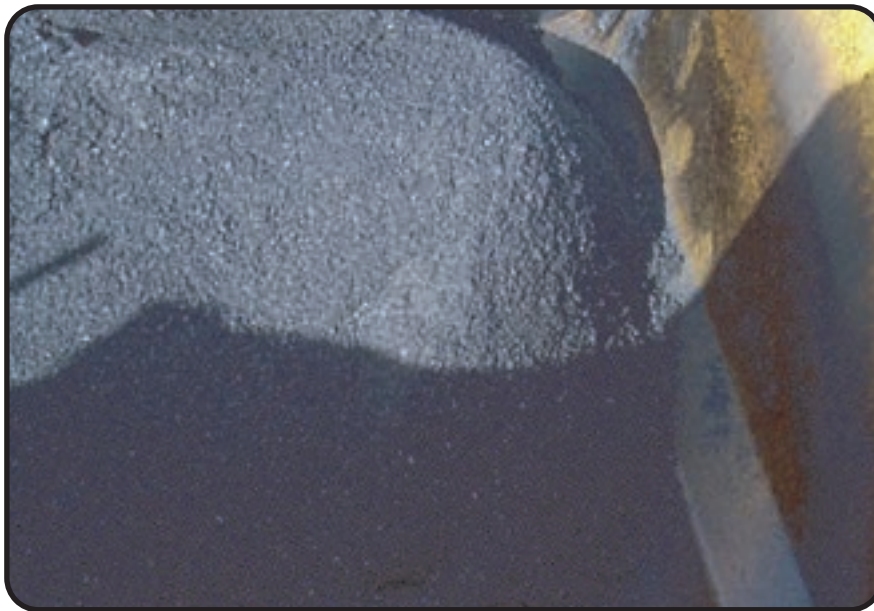
Hot mix in a paver hopper

Figure 3 and Figure 4 show the mix in the paver hopper along with the spot temperatures across the hopper of the paver. It is obvious that the colder material is somewhat stagnant in the wings of the paver hopper. If these wings are dumped, a sufficient amount of cold material will be placed in the mat which results in a temperature differential damaged area.

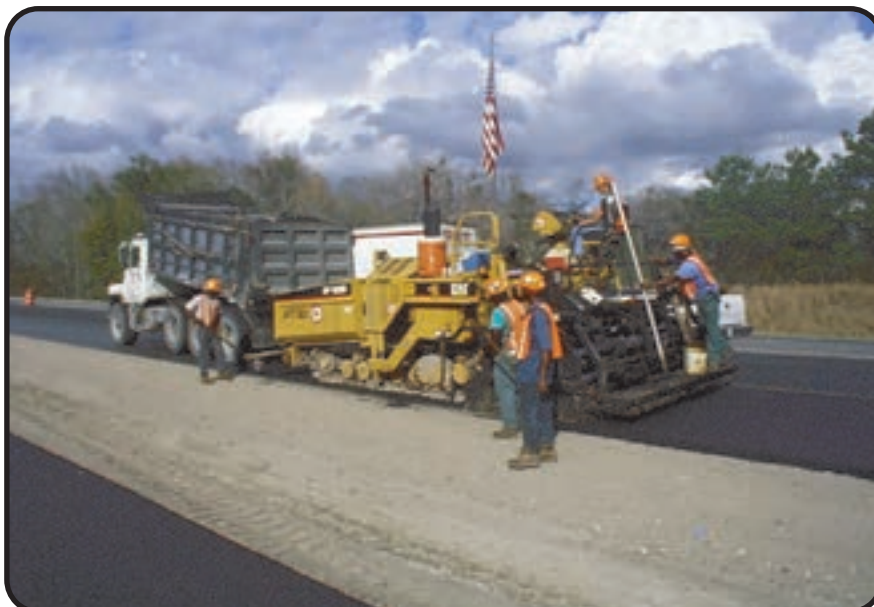
Truck dumping into paver and the mat behind the paver

Figure 5 and Figure 6 show the mat behind the paver along with the spot temperatures. As can be seen, these cold spots are at sufficiently low temperatures, so that it will be impossible to achieve compaction in these areas. After Dr. Joe Mahoney became aware of the infrared camera, he and the Washington Department of Transportation asked Herb Jakob with Astec Industries to bring

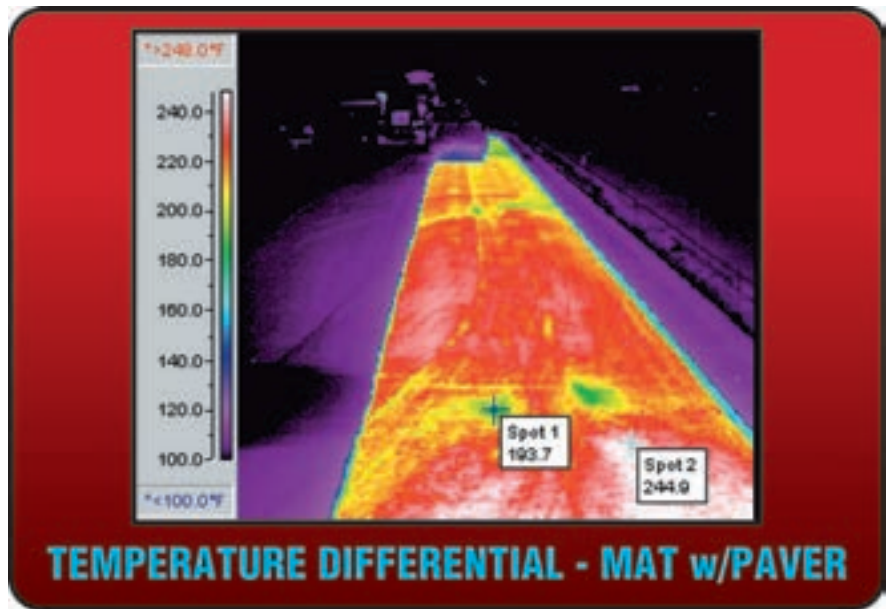
the camera to Washington to study a number of jobs during the summer of 1998. Figure 7 shows the job south of Blaine, Washington where the mix was hauled approximately 55 miles (89 km). The material was dumped through a Cedarapids 551 Remix paver. Utilizing the infrared camera, the cold or nonuniform spots were marked directly behind the paver. After the compaction was complete, nuclear density tests were run in the uniform and nonuniform areas. In addition to the density tests, cores were taken to de-

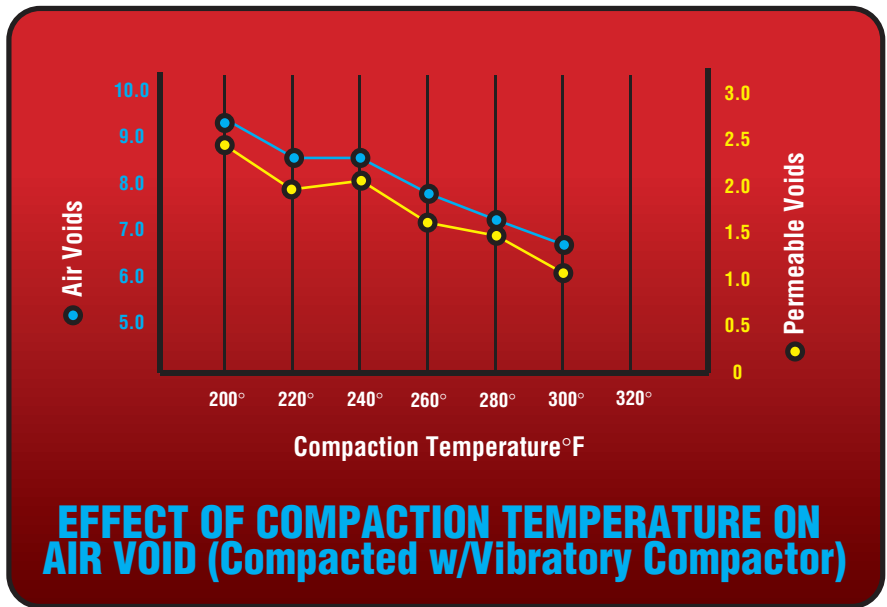
Figure 11 shows the effect on air voids as the temperature is dropped. As can be seen, the air voids drop from approximately 6.8% when compacted at 300° (149°C) to 9.3% when compacted at 200° (93°C). Each of the beams produced from this study was placed in the asphalt pavement analyzer and a fatigue test was run until the beams failed. One such beam is shown in Figure 13. As can be seen from Figure 12, the cycles required to failure decreased significantly as the air voids increased in the pavement. The mix compacted at 220° (104°C) would have approximately 10-12% of the life of the mix compacted at 300° (149°C).

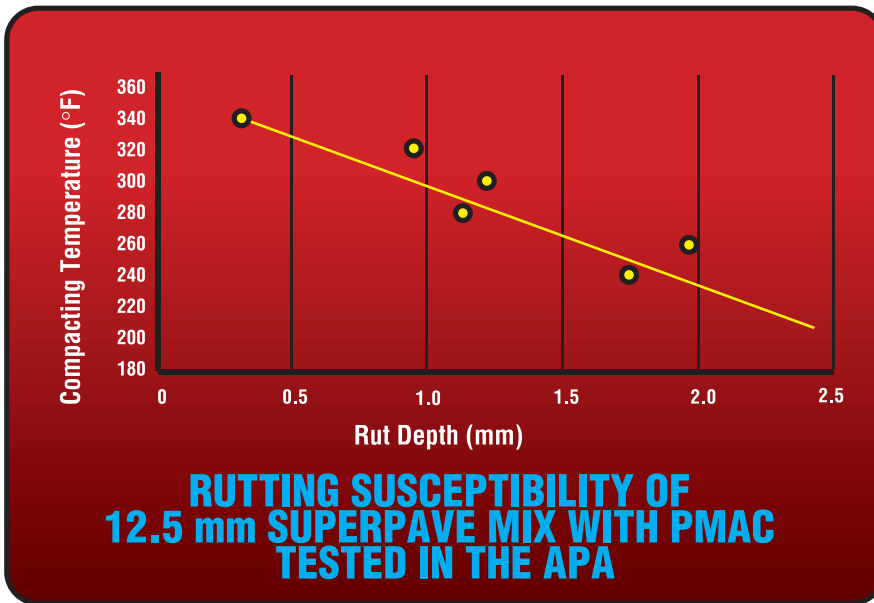
Figure 14 and Table 5 shows the effect of compaction temperatures on rutting and fatigue for a 9 1/2 mm dense graded HMA and Figure 15 and Table 6 shows the rutting susceptibility

of a 12 1/2 mm superpave mix with polymer modified asphalt with variations in compaction temperature. Figure 16 shows pictorially the difference in the rutting that occurs as temperatures vary.

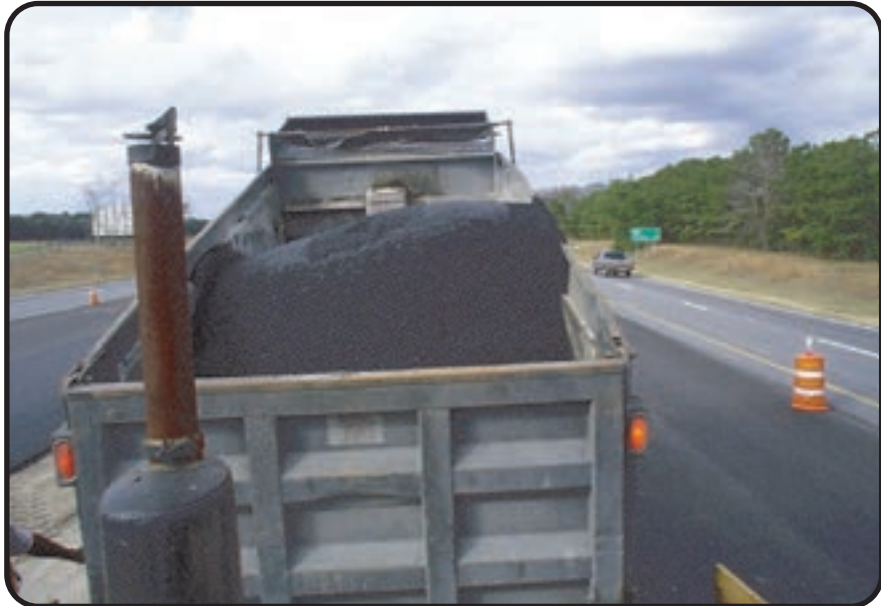
It is obvious that with higher mix temperatures, more temperature differential and more heat loss will occur in the mix. Also greater heat loss will occur when the ambient air temperature is lower. Asphalt and aggregates tend to have relatively low thermal conductivities, resulting in high percentages of cooling around the extremities of a truck bed where the heat loss is occurring. Heat is slowly conducted from the heart or center of the mix out to the edge but due to the low thermal conductivity, high temperature differentials between the edge and the center of the truck occurs as shown in Figure 20 and Figure 21. Basically the mix tends to insulate itself.

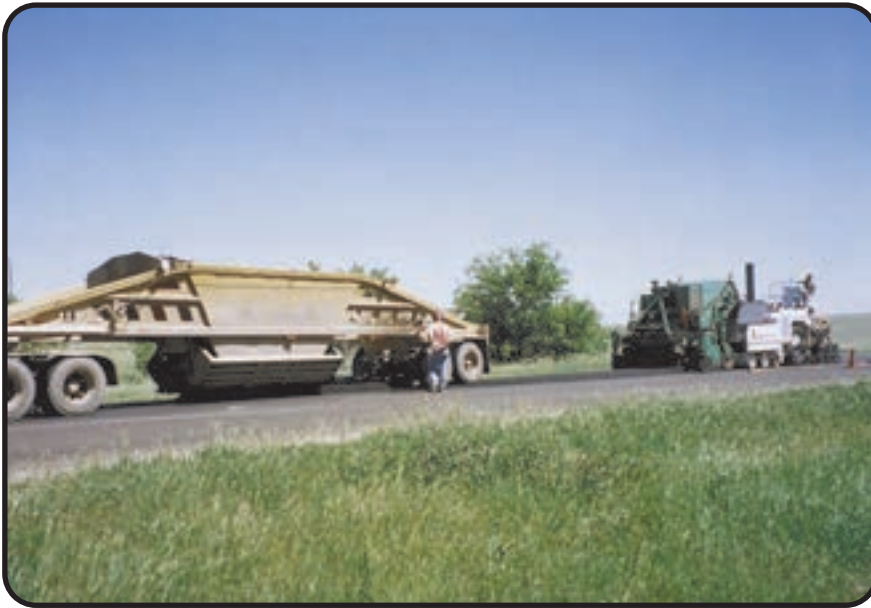
Figure 24

This leads to the conclusion that some type of remixing must be performed immediately prior to placing the mix to achieve a uniform temperature. Read studied various transfer devices to determine their effect on temperature differential damage. These were a windrow pickup device (Figure 24 and Figure 25), a Blaw-Knox transfer machine, and a Roadtec Shuttle Buggy® material transfer vehicle.

While concluding that the windrow pickup device reduced the amount of differential temperature segregation, he noted that keeping the exact amount of mix in the windrow uniformly was difficult. It was also apparent that excess or deficiencies in the windrow would lead to mix being stored for longer or shorter times in the paver hopper, contributing to temperature segregation. Also, belly dump trailers usually dump from the center first with the cold material on the sides being discharged last, leading to concentrations of cold material at the end of each load. While the mat was improved, the temperature segregation was not eliminated.

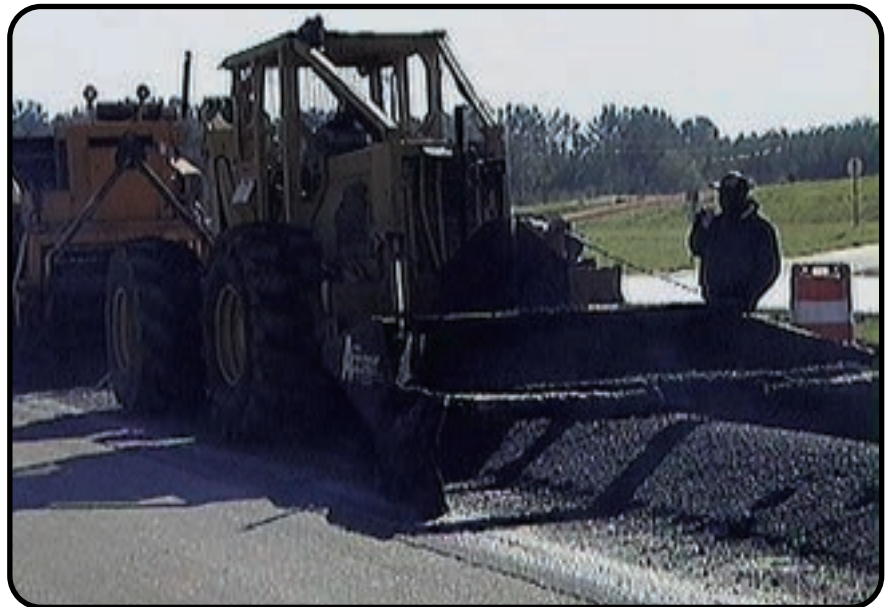
Figure 26 shows a windrow placing device often used in Mississippi which is intended to remix the material in the windrow prior to it being picked up by the pickup machine. As can be seen from the infrared photograph (Figure 27) taken behind this machine, the remixing for temperature is minimal when

using this machine. When this photograph was taken, the mix had been hauled 10 miles (16 km).

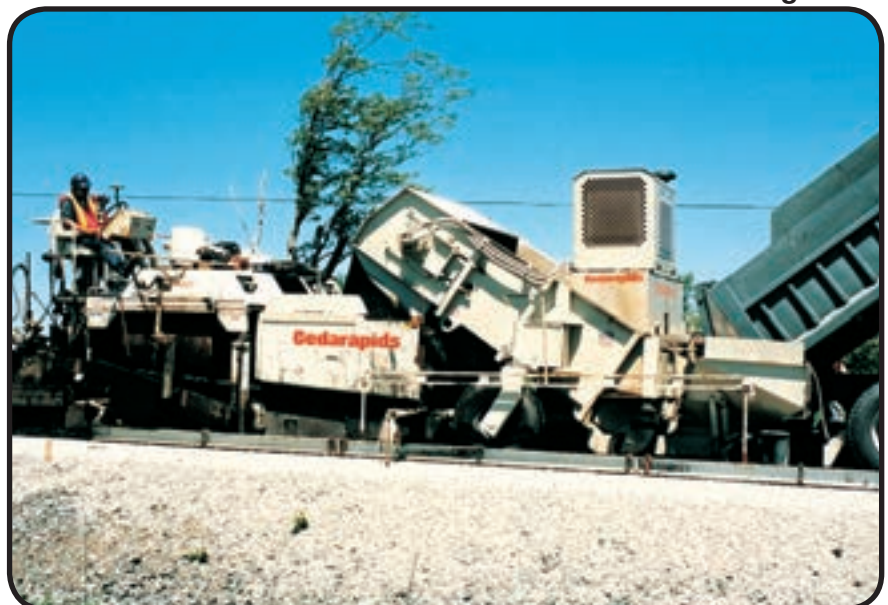
Figure 28 shows the Cedarapids MS-3 on a job in Nova Scotia and Figure 29 shows the infrared photograph behind it. The MS-3 is basically a material transfer machine allowing more storage in the paver but does little remixing as can be seen from the infrared. Figure 30 shows the Cedarapids remix paver and Figure 31 shows the augers inside of the remix paver. Figure 32 shows the infrared behind this machine after a 55- mile (89 km) haul. As can be seen, little remixing for temperature occurs when utilizing this device.

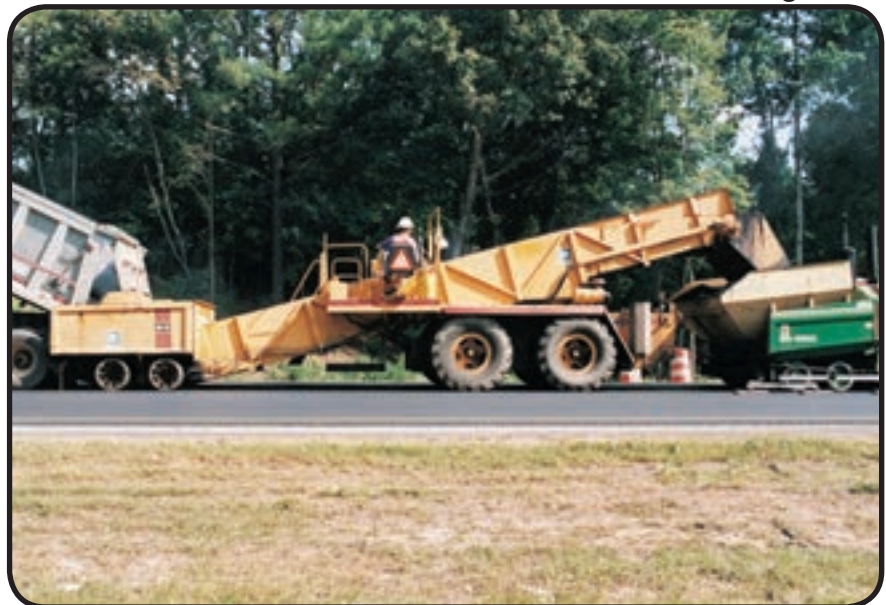
Figure 33 shows the Blaw-Knox transfer machine, which is basically a belt transfer machine that has minimal remixing. While this machine improves the mat, it still demonstrates the same amount of temperature segregation, as seen in Figure 34. Figure 35 shows an improvement on this machine with an insert (as seen in Figure 36) containing a mixer in the bottom of the paver hopper. Figure 37 shows the infrared temperature of the mat behind this combination. While improved, there is still significant temperature differentials.

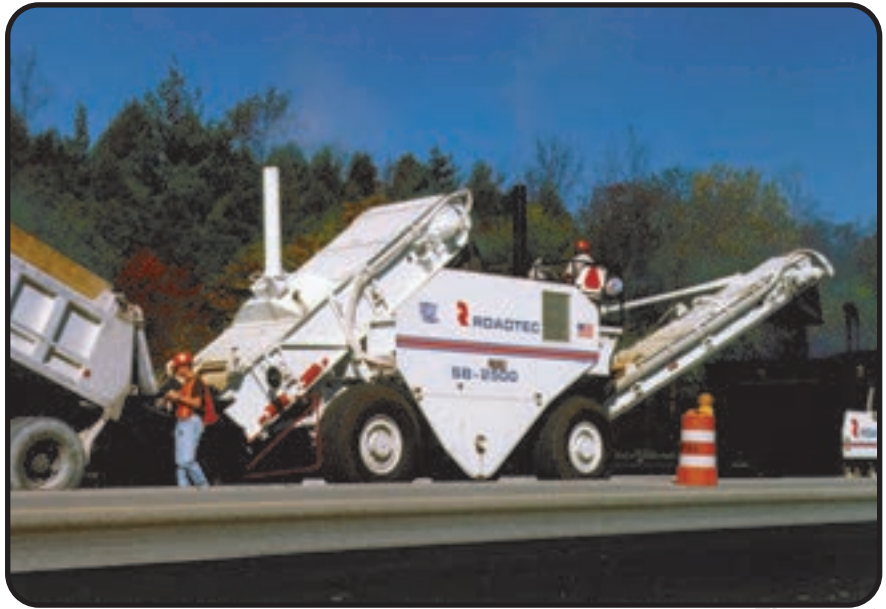
Figure 38 shows the Roadtec material transfer vehicle. This machine has triple pitch augers (as shown in Figure 40) in the bottom of the storage hopper. The machine will store approximately 25 metric tons or 30 short tons. When augers are used as shown in Figure 39, no remixing occurs since all of the mix is fed in from the inlet end of the auger. This results in all of the material being conveyed from the outside of the hopper with the center emptying last. By changing the pitch of the auger, as shown in Figure 40, new material can enter the flights as the flights spread out or the pitch changes. Since the pitch changes twice on each side of the hopper (transversely to the direction of the paver) is remixed or rebleded, with the cold or coarse material being rebleded with the hot or finer material from the quarter points and the center of the machine.

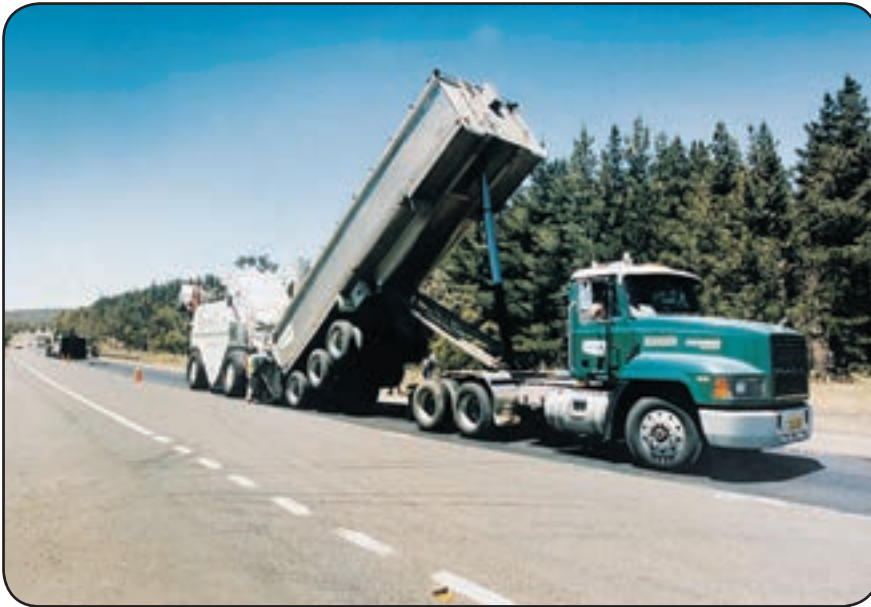
Figure 46

Again in early 1997 a contractor in Australia hauled mix 150 miles one way (241 km), resulting in a 176° F (80° C) temperature on the outside of the truck; on the top the mix was 205° F (96° C), but in the center of the load the mix was still 305° F (152° C). After remixing through the Roadtec material transfer vehicle, the temperature discharge from the machine was 284° F (140° C) see *Figure 46, Figure 47 and Figure 48*. The result pavement was uniform in density and very smooth.

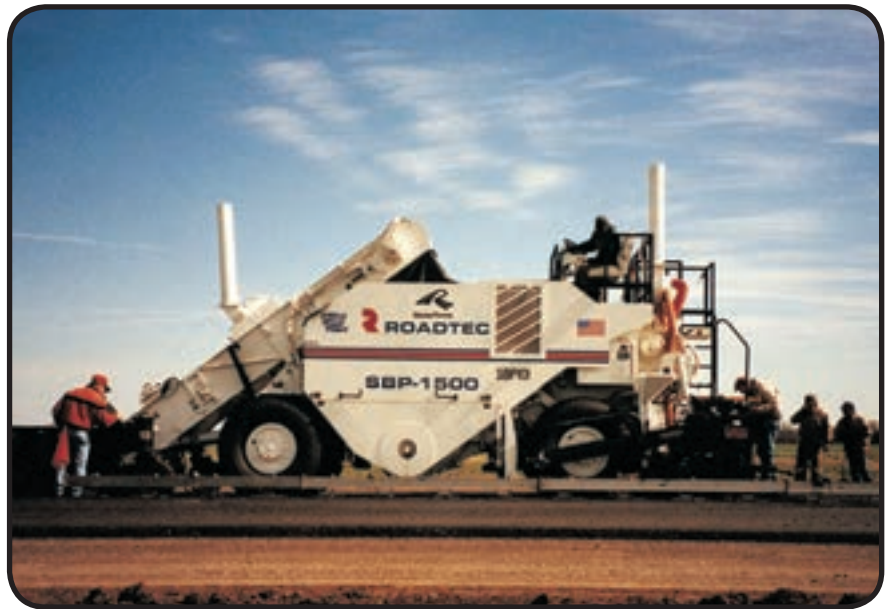
Figure 49

From this it becomes apparent that unless an extremely short haul in good weather occurs, some type of remixing directly prior to placing the mix into the paver should occur in order to achieve a uniform consistent mix in the mat. When belly dump trucks are used and windrow paving occurs, a Shuttle Buggy with a windrow pickup head gives the advantage of having storage and remixing. By incorporating the augers and screed on the rear of the machine, the Shuttle Buggy becomes a paver. This integrated machine accomplishes the same job as the paver and pickup machine and insures a uniform temperature in the mat behind the paver. Such a device is shown in *Figure 49*.
